IMAGE IN CARDIOLOGY

An extremely rare but considerably important device-related complication of percutaneous atrial septal defect closure

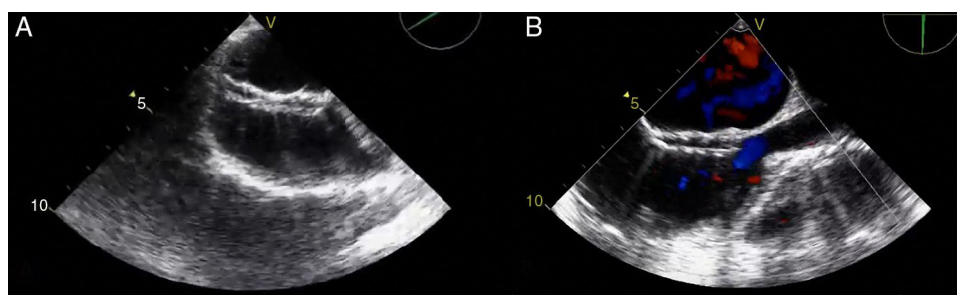
Figure 1 TEE images demonstrate that the occluder device was properly deployed in the middle part of the interatrial septum (A) and there was no residual shunt through it (B).

during the procedure ensured that the occluder device was properly deployed in the middle part of the interatrial septum and there was no residual shunt through it (Figure 1). There were also no problems with the occluder device at 1-month follow-up. However, four months after the procedure, the patient presented again with vague chest pain, palpitations and shortness of breath. The physical exami-

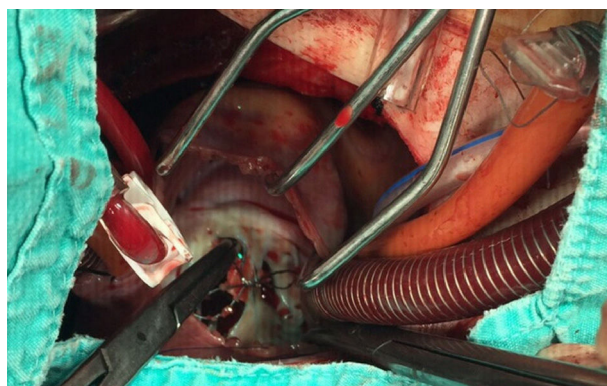
Figure 2 Intraoperative imaging showing that all margins of the occluder device were properly attached to the interatrial septum and there was no displacement.

nation was unremarkable. Transthoracic echocardiography (TTE), followed by TEE, revealed a significant left-to-right shunt, although the device was clearly seen in the middle part of the interatrial septum. The initial differential diagnosis included partial displacement of the device and therefore, the patient was referred to surgery, all margins of the occluder device were found to be properly attached to the interatrial septum during the surgery (Figure 2). Interestingly, the central patch of the device had almost completely disappeared (Figure 3). Surgical repair of the atrial septum was performed successfully after removing the metallic part of the device. There were no signs of emboli in the brain or pulmonary vasculature on the computed tomography scan, which was performed following the surgery for any possible embolisation of the patch material. The patient was discharged from the hospital without any complications and in good health.

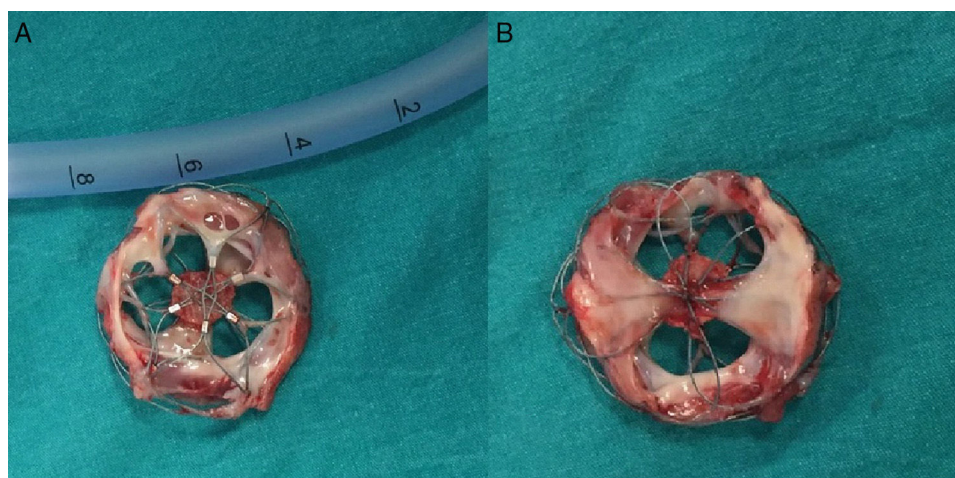
Figure 3 Imaging of the occluder device after surgical extraction from the front (A) and the back (B) sites.

In conclusion, although device closure of ASDs can safely be performed percutaneously, recanalisation may occur on rare occasions, probably due to device characteristics of the Ultrasept ASD Occluder. While ASD occluder devices from this brand are usually preferred due to their super-low profile, this feature of the devices may not provide necessary support and resistance in the interatrial septum. As a matter of fact, the last generation of Ultrasept ASD Occluder devices have an extra layer between the two other layers, indicating this kind of necessity.
