## IMAGE IN CARDIOLOGY

# An extremely rare but considerably important device-related complication of percutaneous atrial septal defect closure

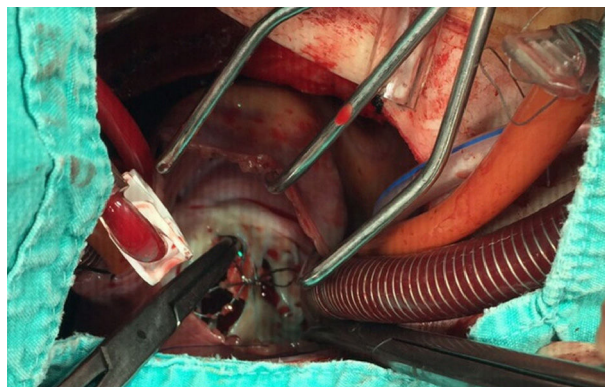
**Figure 2** Intraoperative imaging showing that all margins of the occluder device were properly attached to the interatrial septum and there was no displacement.

nation was unremarkable. Transthoracic echocardiography (TTE), followed by TEE, revealed a significant left-to-right shunt, although the device was clearly seen in the middle part of the interatrial septum. The initial differential diagnosis included partial displacement of the device and therefore, the patient was referred to surgery, all margins of the occluder device were found to be properly attached to the interatrial septum during the surgery (Figure 2). Interestingly, the central patch of the device had almost completely disappeared (Figure 3). Surgical repair of the atrial septum was performed successfully after removing the metallic part of the device. There were no signs of emboli in the brain or pulmonary vasculature on the computed tomography scan, which was performed following the surgery for any possible embolisation of the patch material. The patient was discharged from the hospital without any complications and in good health.
