Successful percutaneous closure of a residual atrial septal defect due to device failure

Abstract A 39-year-old woman underwent uneventful percutaneous occlusion of an ostium secundum atrial septal defect (ASD) with a 22 mm Ultrasept ASD Occluder[®]. Transesophageal echocardiography (TEE) performed two years after implantation revealed a de novo residual left-to-right shunt through the correctly implanted device. Three-dimensional transesophageal echocardiography (3D TEE) further clarified this finding by showing a perforation of the device membrane coating. The patient underwent transcatheter closure of the residual shunt with a 20 mm Ultrasept PFO[®] device. The procedure was guided by fluoroscopy and real-time 3D TEE. At the end of the procedure 3D TEE documented correct device deployment with complete defect coverage and absence of residual shunt.

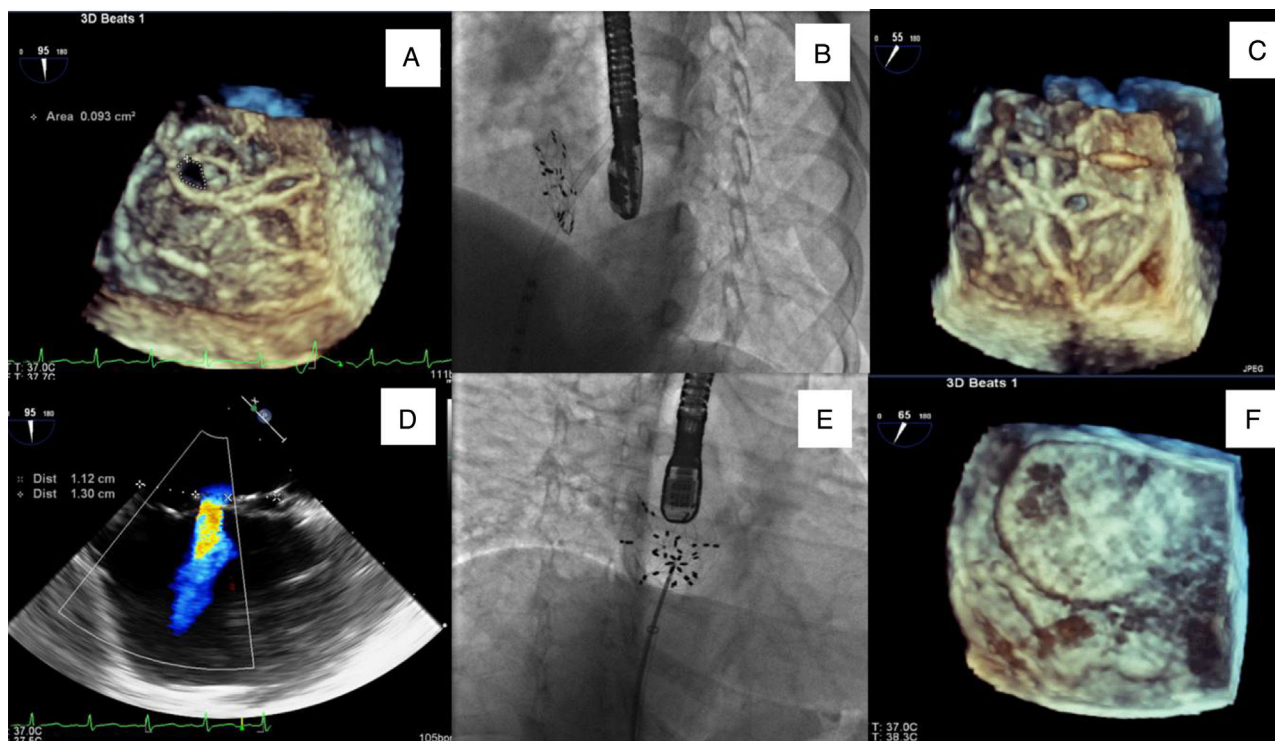
A 39-year-old woman presented for percutaneous closure of an ostium secundum atrial septal defect (ASD) with a balloon-sized diameter of 21 mm, which was performed successfully using a 22 mm *UltraSept ASD Occluder*[®] (Cardia, Eagan, MN, USA) with no complications, under fluoroscopic and transesophageal echocardiography (TEE) guidance. The day after the procedure, transthoracic echocardiography (TTE) showed a correctly placed device with no residual shunt. Two years after the procedure, TTE followed by TEE revealed a residual left-to-right shunt through the correctly implanted device. Three-dimensional (3D) TEE enabled more detailed characterization, showing a perforation of the membrane coating 0.09 cm² in area on the inferior portion of the device (*Figure 1A* and *D*). Although there were no obvious signs of right ventricular overload,

Figure 1 (A and D) Three- (3D TEE) and two-dimensional transesophageal echocardiography images showing residual shunt through the device (22 mm *UltraSept ASD Occluder*[®]); (B and C) delivery sheath through the *UltraSept* device in fluoroscopic view and in 3D TEE; (E and F) closure of residual shunt in the 22 mm *UltraSept* device with a 20 mm *UltraSept PFO* device, with the final result documented in fluoroscopic view and in 3D TEE.

She accordingly underwent a second cardiac catheterization for hemodynamic measurement and possible transcatheter closure of the residual shunt. The procedure was performed under general anesthesia, guided by fluoroscopy and real-time 3D TEE (*Figure 1B, C, E* and *F*). The Qp:Qs obtained by catheterization was 1.7 and therefore we decided to proceed with implantation of a second device. We chose a 20 mm *UltraSept PFO occluder* with the expectation that a similar device would conform better to the previously implanted occluder.

The device defect was crossed with a combination of a 6 F right Judkins diagnostic catheter (Boston Scientific, Natick, MA) and a standard 0.35" *ZIPwire*[™] Hydrophilic Guide Wire (Boston Scientific, Natick, MA) placed in the left superior pulmonary vein. We opted not to perform balloon sizing;

otherwise the interventional procedure was performed with the standard ASD closure technique, taking extra care with the 9 F delivery sheath to avoid displacement of the device already in place.

At the end of the procedure 3D TEE documented correct device placement with complete defect coverage and absence of residual shunt.

We adopted a percutaneous approach guided by real-time 3D TEE, which offered precise spatial location of the perforation and orientation of sheaths and devices. A 20 mm Ultrasept PFO occluder was chosen because (a) it appeared to be the most easily adjustable for the small but asymmetric hole, (b) no residual holes have been reported in these devices, (c) we thought that it would be better to juxtapose two devices with the same type of frame, and (d) it has a
